LAKE WORTH LAGOON MONITORING PROJECT

FINAL REPORT
DEP AGREEMENT NO. WAP028
PBC NO. R2001-0401

Revised
November 2003

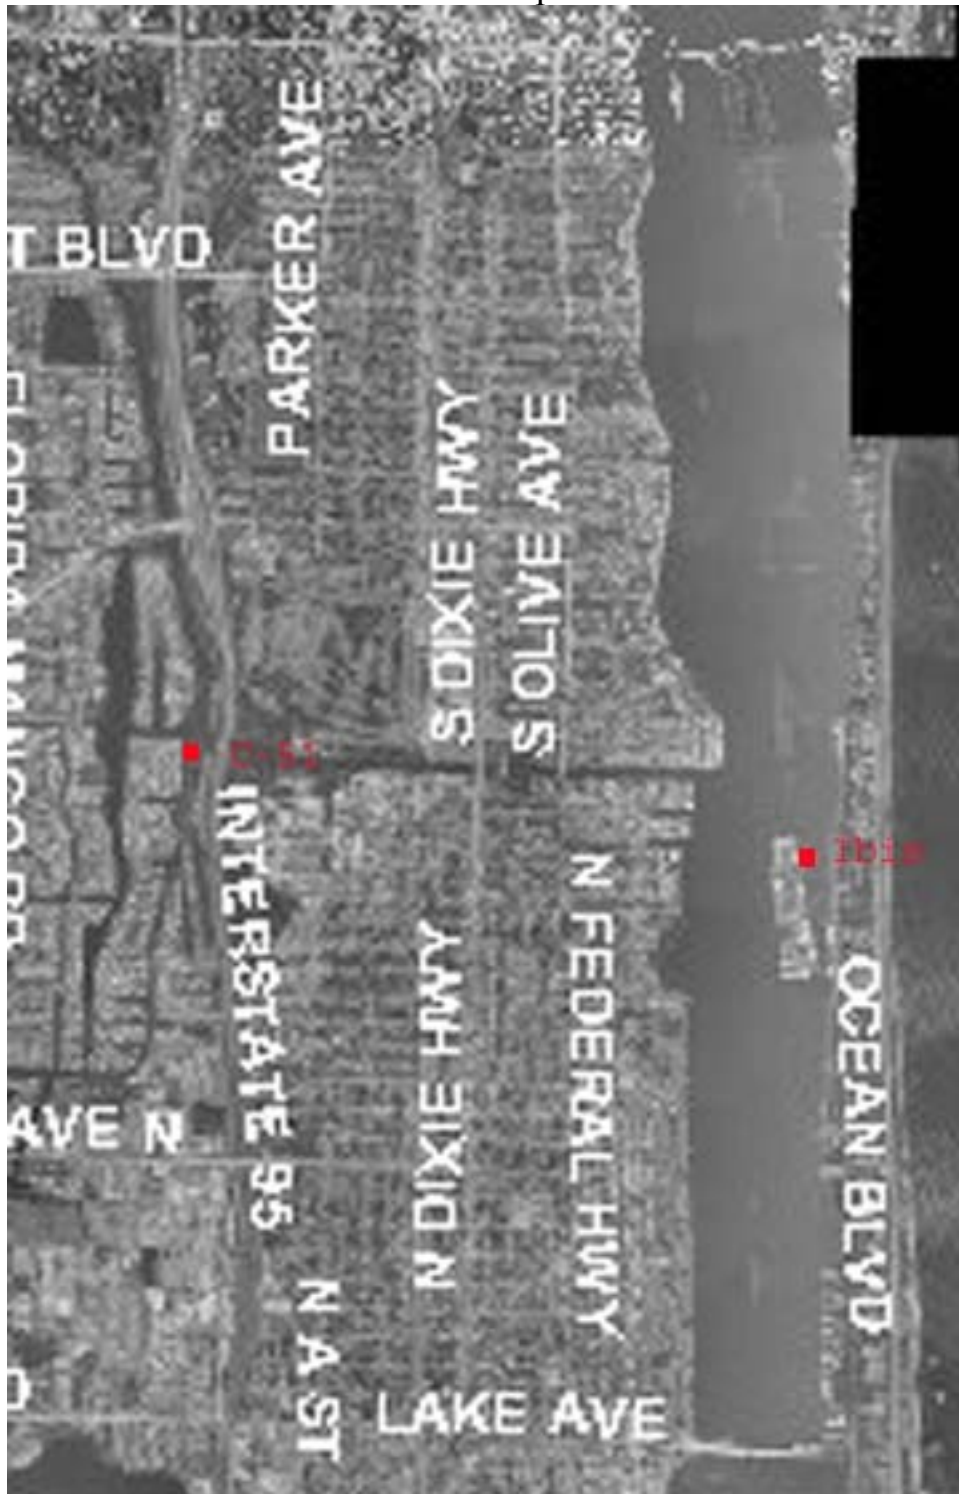
Attachment 3 – Central Lake Worth Lagoon Muck Sediment Monitoring,
Phase II-1a – Preliminary Study,
Site Map

Three cores were collected from site Ibis, they were: Ibis-1, Ibis-FD (Field Duplicate), and Sed-Ibis (Accumulation rate analysis). Collection of a core was not possible at site C-51, therefore a ponar grab sample was collected.

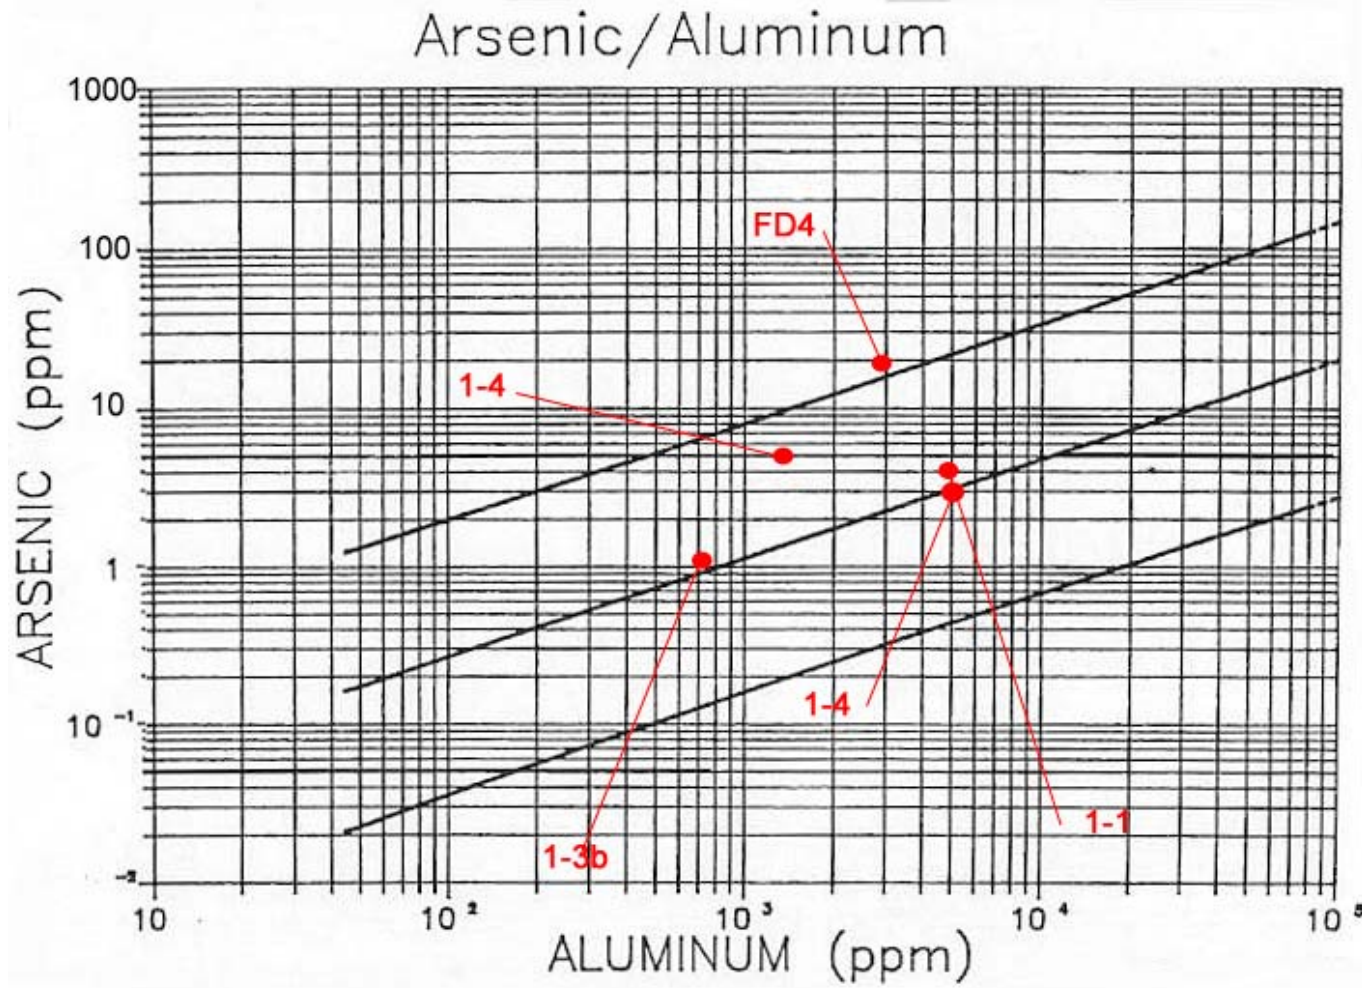
Attachment 7 – Central Lake Worth Lagoon Muck Sediment Monitoring,
Phase II-1a – Preliminary Study,
Metals concentrations in relation to Aluminum

Arsenic concentrations were below the detection limit (0.75mg/Kg) in samples Ibis1-2, Ibis1-3a, IbisFD1, IbisFD3, and C-51.

These results appear to show significant anthropogenic contribution of lead, copper, and chromium. . As far as the lead is concerned, both the absolute concentrations and the concentrations in comparison to aluminum seem to show more recent deposition. Higher concentrations of copper are found in the upper layers, but in comparison to aluminum, the ratio is higher in deeper layers. Chromium did not appear to reveal any temporal trends in regard to its concentration in comparison to aluminum.

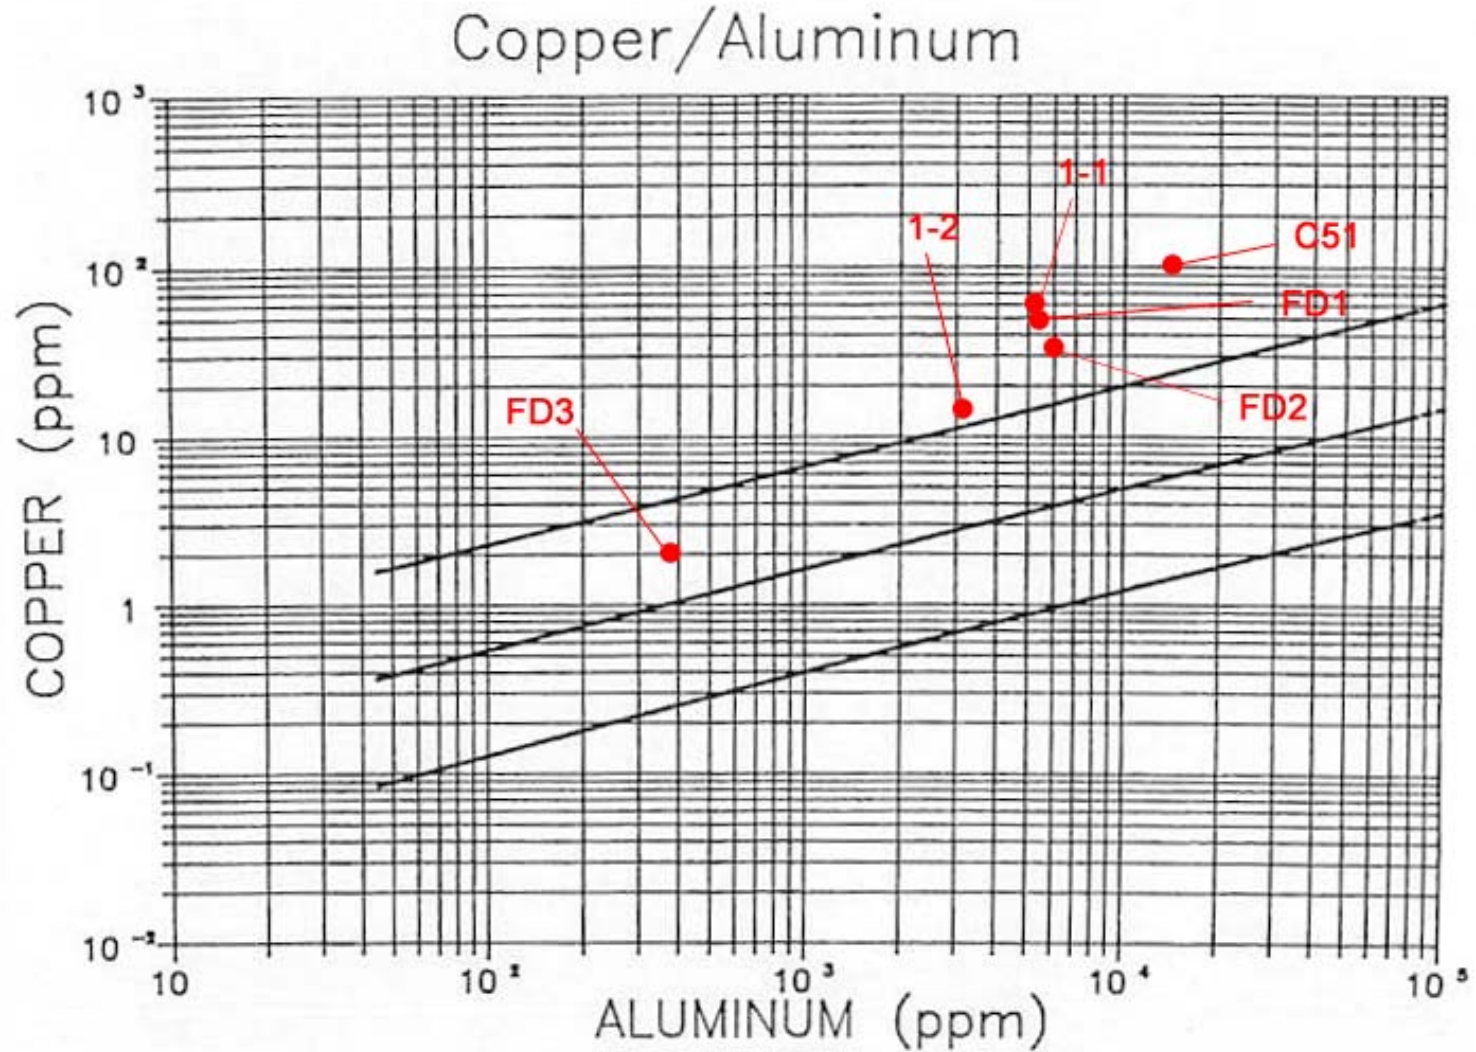
Attachment 7 – Central Lake Worth Lagoon Muck Sediment Monitoring,
Phase II-1a – Preliminary Study,
Metals concentrations in relation to Aluminum

Copper concentrations were below the detection limit (1.0 mg/Kg) in samples Ibis1-3a, Ibis1-3b, Ibis1-4, and IbisFD4.

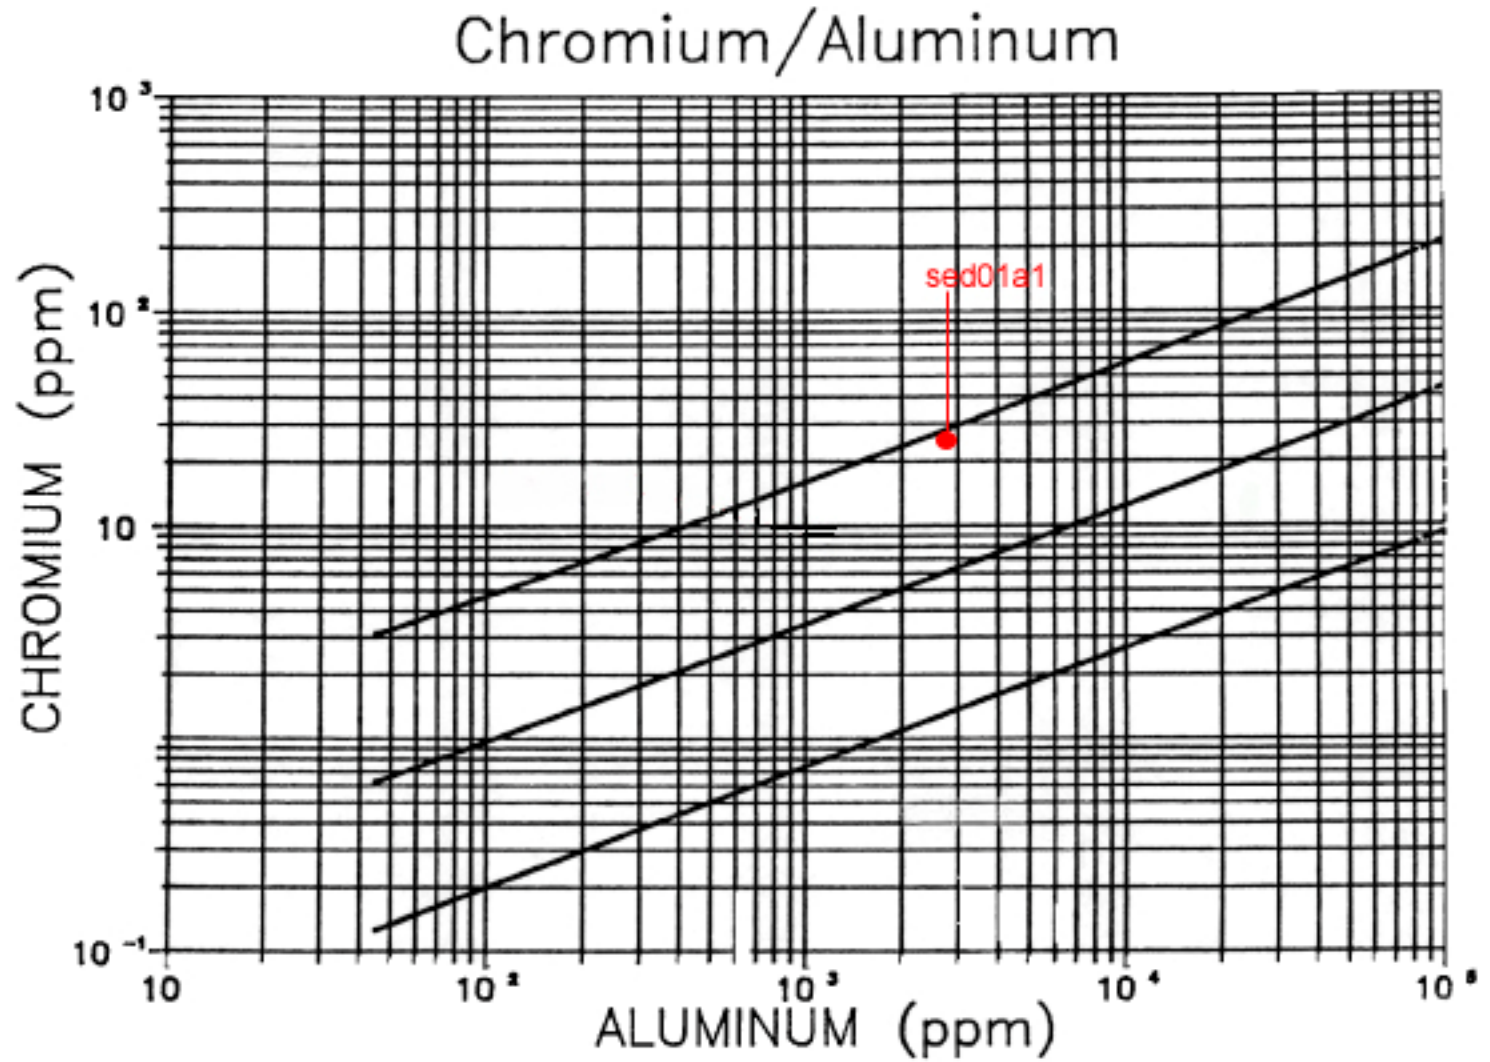
Attachment 14 – Central Lake Worth Lagoon Muck Sediment Monitoring,
Phase II-1b – Expanded Study,
Metals concentrations in relation to Aluminum

Chromium concentrations were below the detection limit of 1.0 mg/Kg in all other samples.

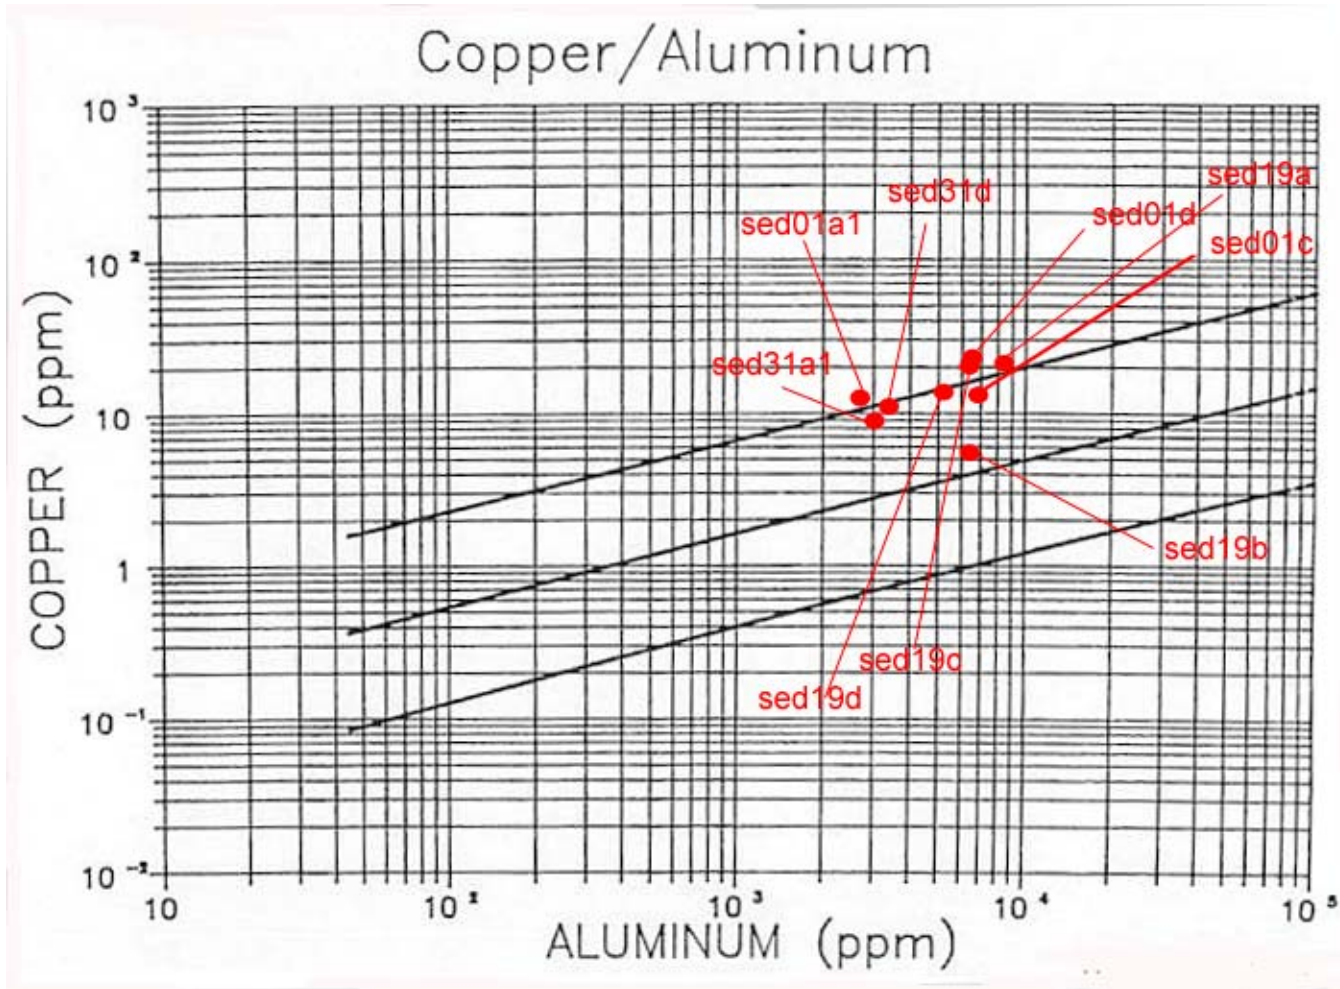
Attachment 14 – Central Lake Worth Lagoon Muck Sediment Monitoring,
Phase II-1b – Expanded Study,
Metals concentrations in relation to Aluminum

Copper concentrations were below the method detection limit (MDL) in samples sed01a2, sed01b, sed31a2, sed31b, and sed31c.

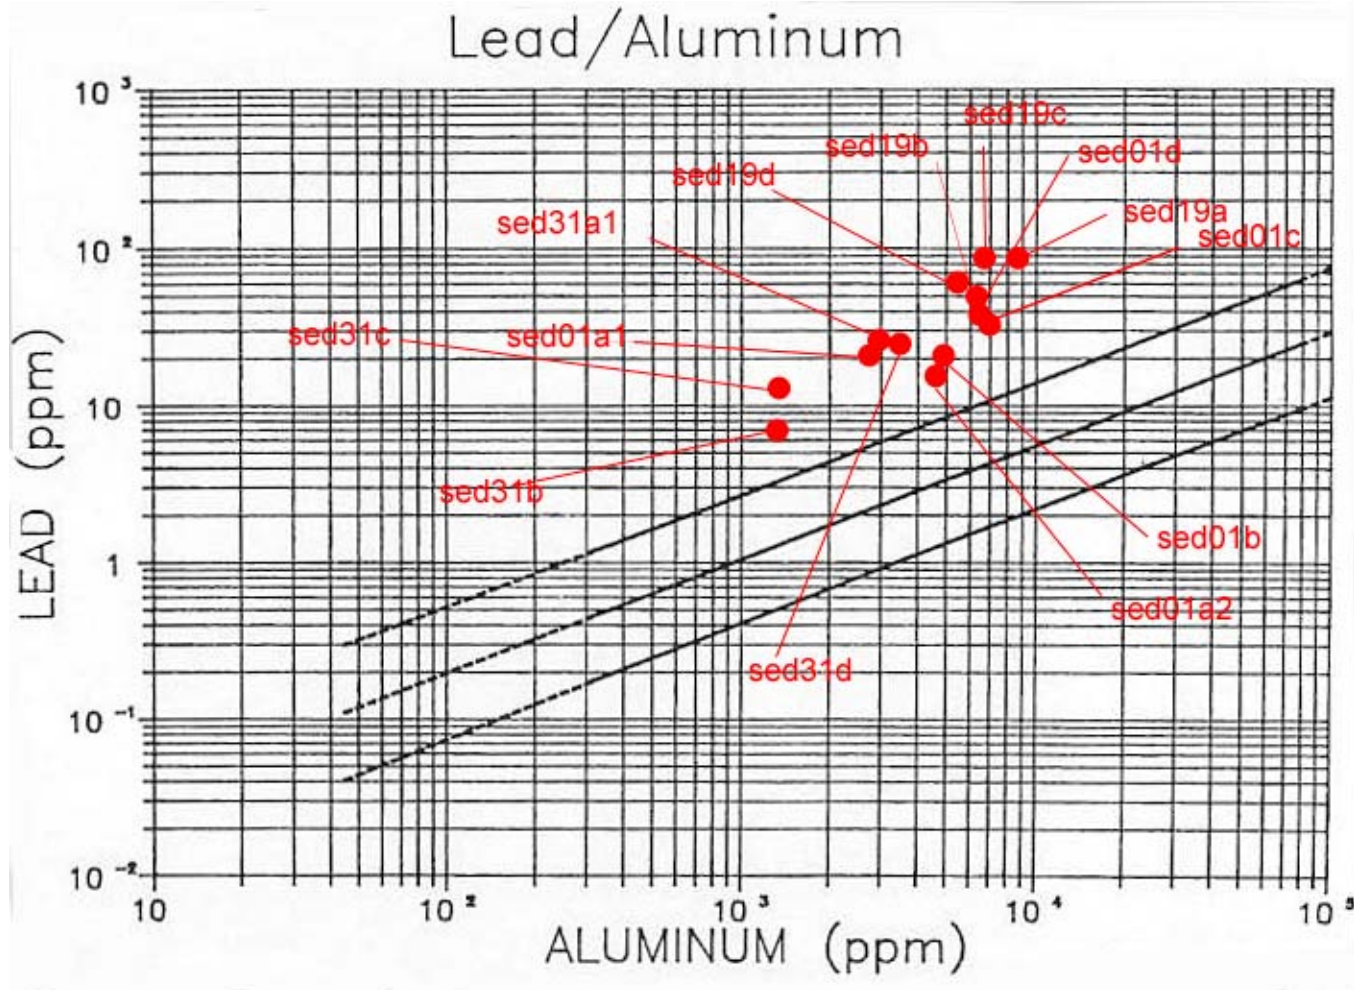
Attachment 14 – Central Lake Worth Lagoon Muck Sediment Monitoring,
Phase II-1b – Expanded Study,
Metals concentrations in relation to Aluminum

Lead concentration was below the method detection limit in sample sed31a2.

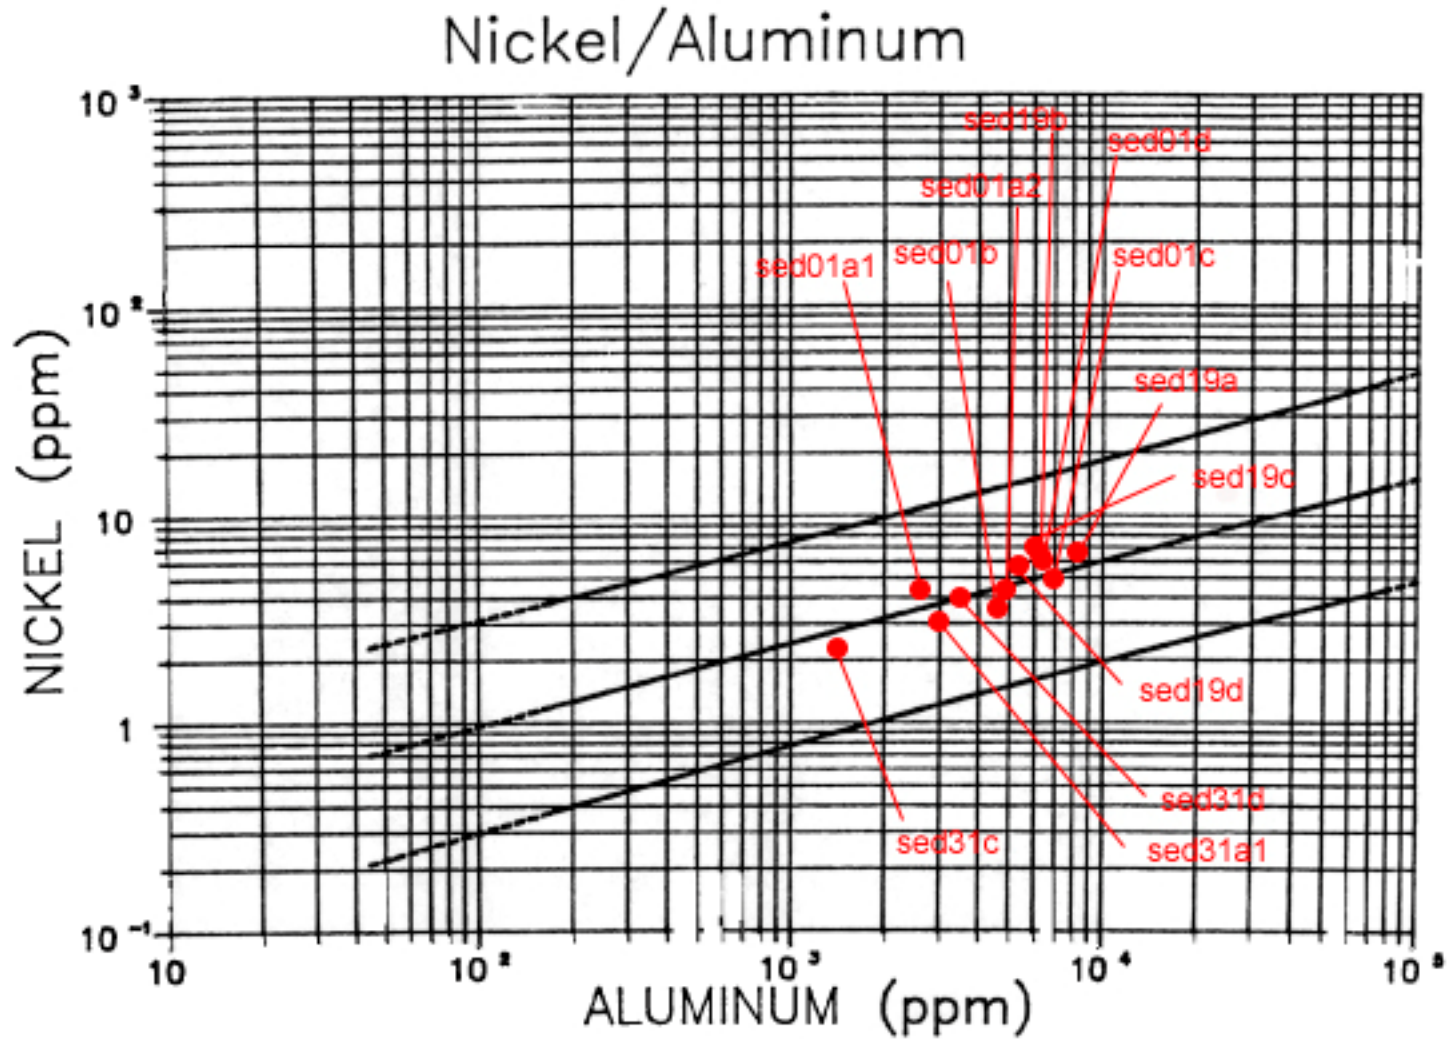
Attachment 14 – Central Lake Worth Lagoon Muck Sediment Monitoring,
Phase II-1b – Expanded Study,
Metals concentrations in relation to Aluminum

Nickel concentrations were below the detection limit of 1.0 mg/Kg in samples Sed01a2, and Sed01b.

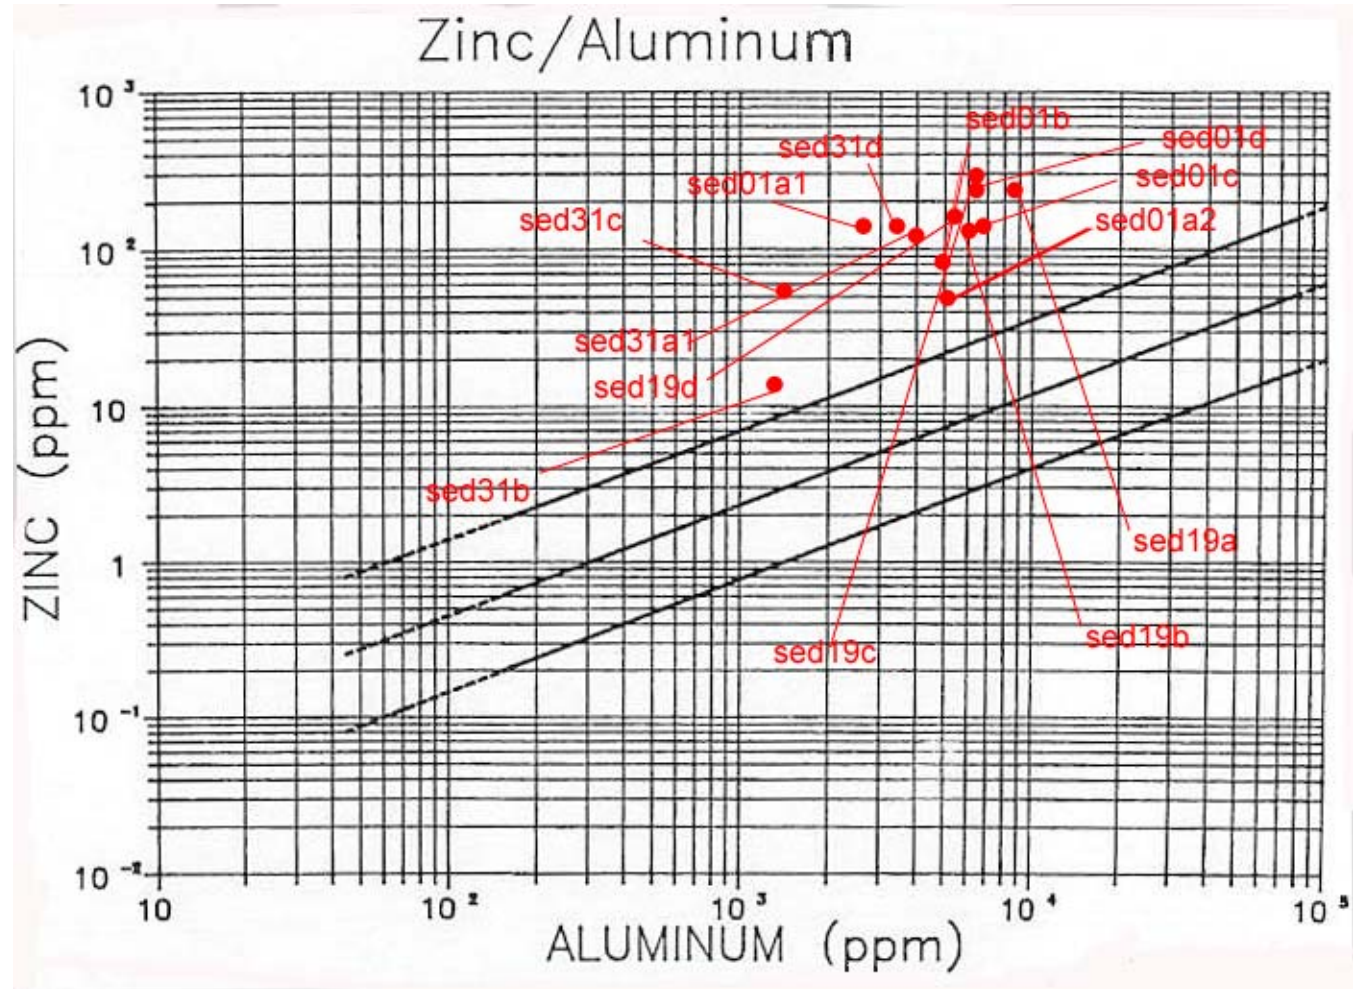
Attachment 14 – Central Lake Worth Lagoon Muck Sediment Monitoring,
Phase II-1b – Expanded Study,
Metals concentrations in relation to Aluminum

Zinc concentration was below the method detection limit (MDL) in sample sed31a2.

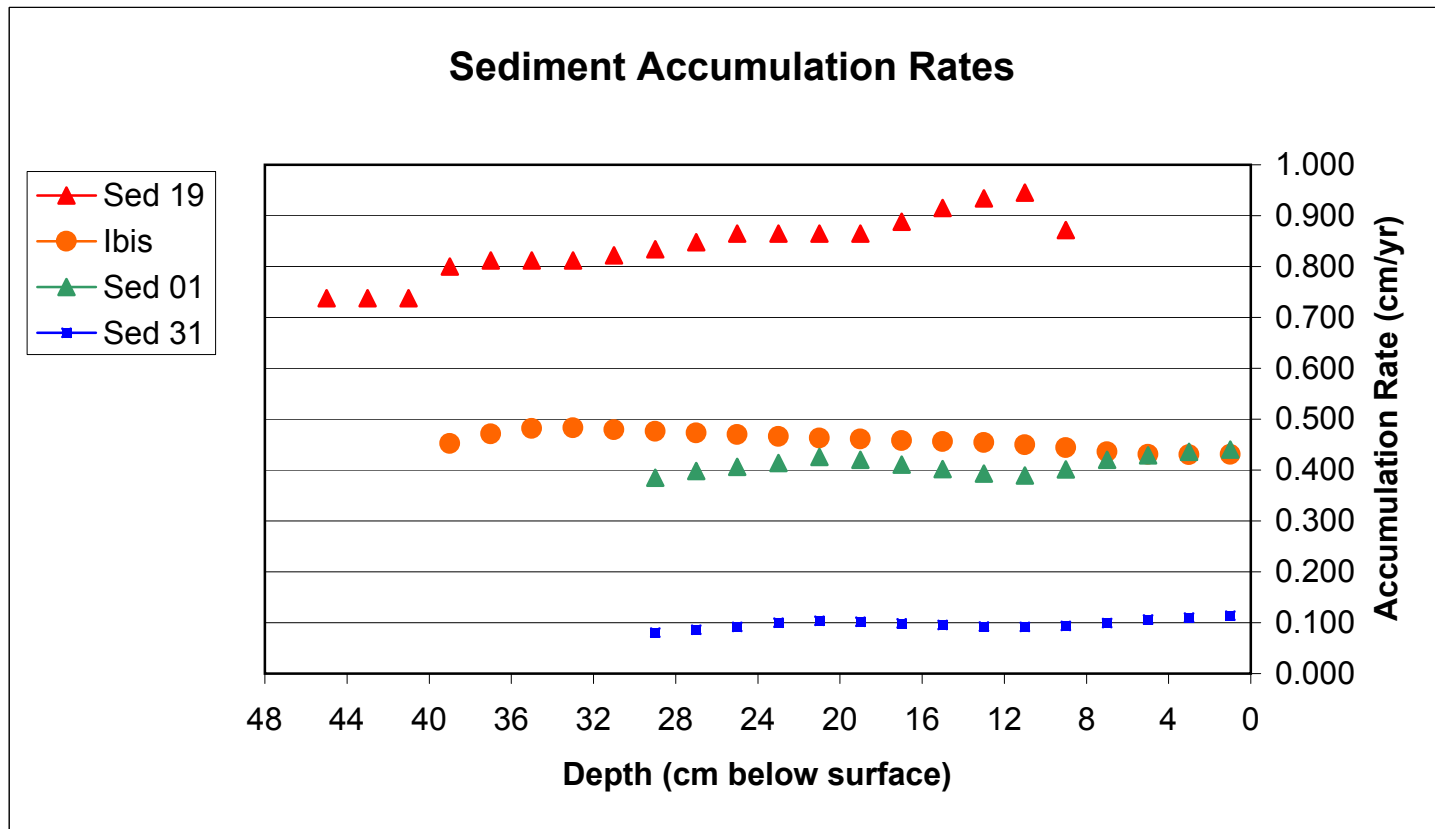
Attachment 16 - Central Lake Worth Lagoon Muck Sediment Monitoring,
Phase II-1a - Preliminary and Expanded Study,
Comparative Sediment Accumulation Rates

Sediment cores were analyzed in 2 cm sections.

Core Sed19 had a high degree of mixing in the top 4 layers (top 8 cm) making accurate accumulation rate assessment impossible.
